## W Warren and 2<sup>nd</sup> Street Ditch

This drainage issue was reported by the owner of the property located at 140 W Warren St. The owner explained that this has been an ongoing issue for several years. The owner stated that when it rains the stormwater will not drain properly which causes it to back up onto his property and buildings. Our findings were as follows:

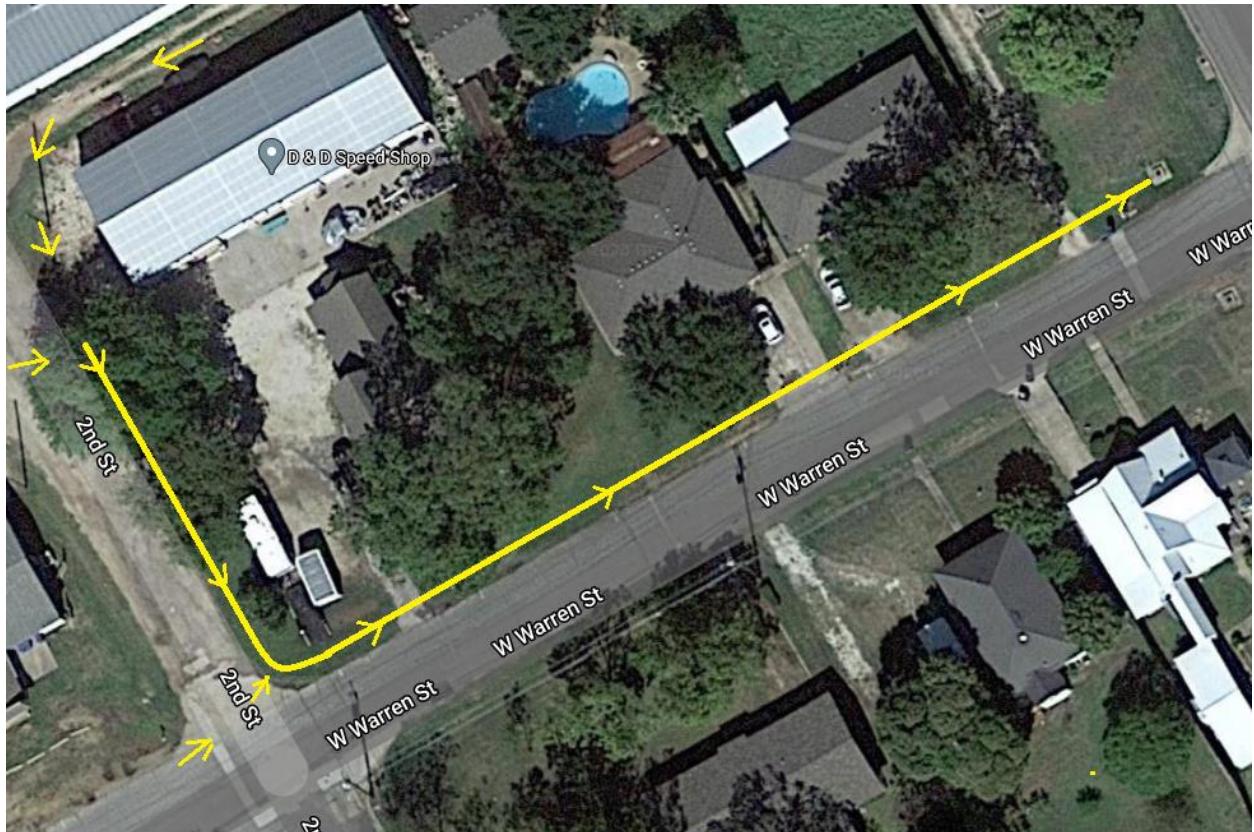
- The ditch on 2nd Street was so heavily silted it was nonexistent. The driveway located on 2nd street going into D&D had a makeshift culvert pipe consisting of a section of 6" steel mated to another section of 6" class pvc water pipe. The piping was broken down and stopped up completely. We replaced this with a section of 12" corrugated tin horn. A grade of 1.0% was established and a ditch was dug from the driveway to the corner of 2nd Street and W Warren St. Water naturally flows from several different directions down this path and to this corner.

- The ditch on W Warren was heavily silted from the corner of 2nd St to the receiving vault located at W Warren and South 1st St. There are 4 driveways located within this stretch of the ditch. Each one has piping ranging from 10-12". The ditch and mouths of the pipes were heavily silted. All of the pipes were stopped up, two of which were completely covered with the tops barely visible. Each pipe was cleaned out. We used a grade of 1% to desilt the ditch from the corner of 2nd Street to the receiving vault. Approximately 4-6" of silt was removed throughout.

- All areas requiring excavation were covered with erosion control blanketing and seeded with grass seed.
