## Castleman Creek/ Chapman Road Creek Crossing.

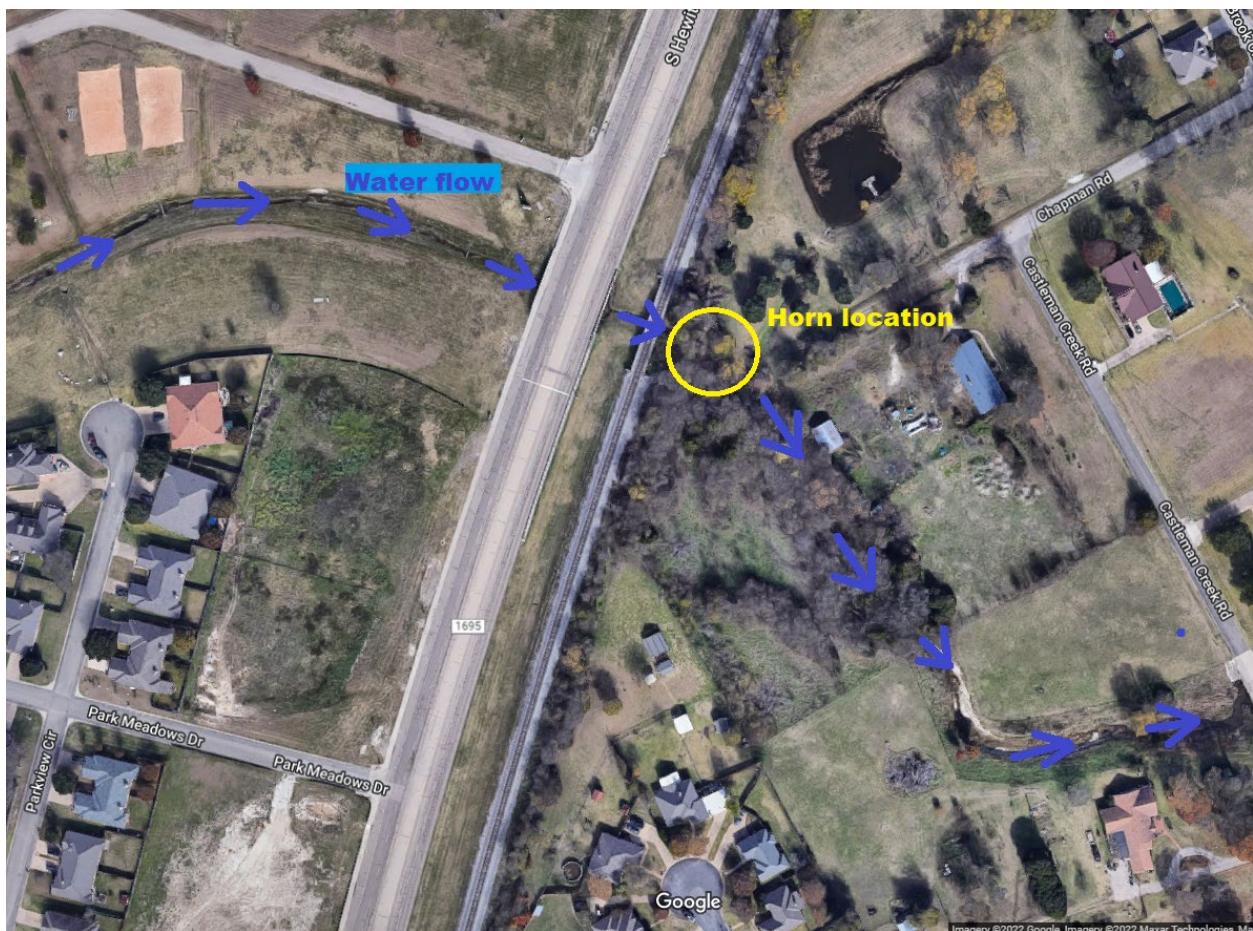
(Yellow is the crossing location, and the blue arrows represent the water path and flow direction)

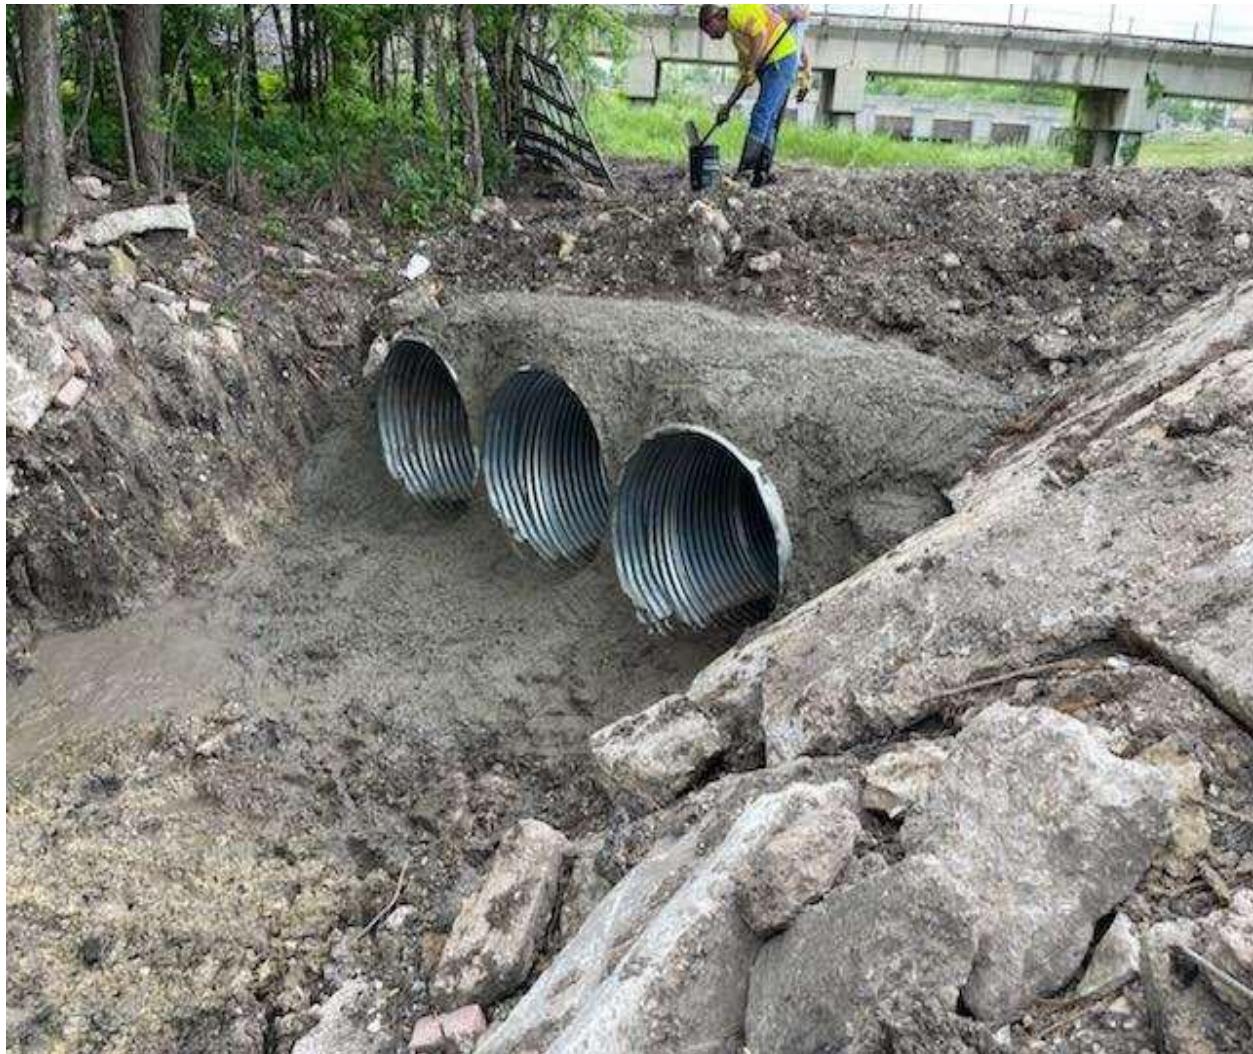
(End treatment of cement to help avoid erosion)

To increase flow capacity in this location, staff has added 3 more 48" tin horns.

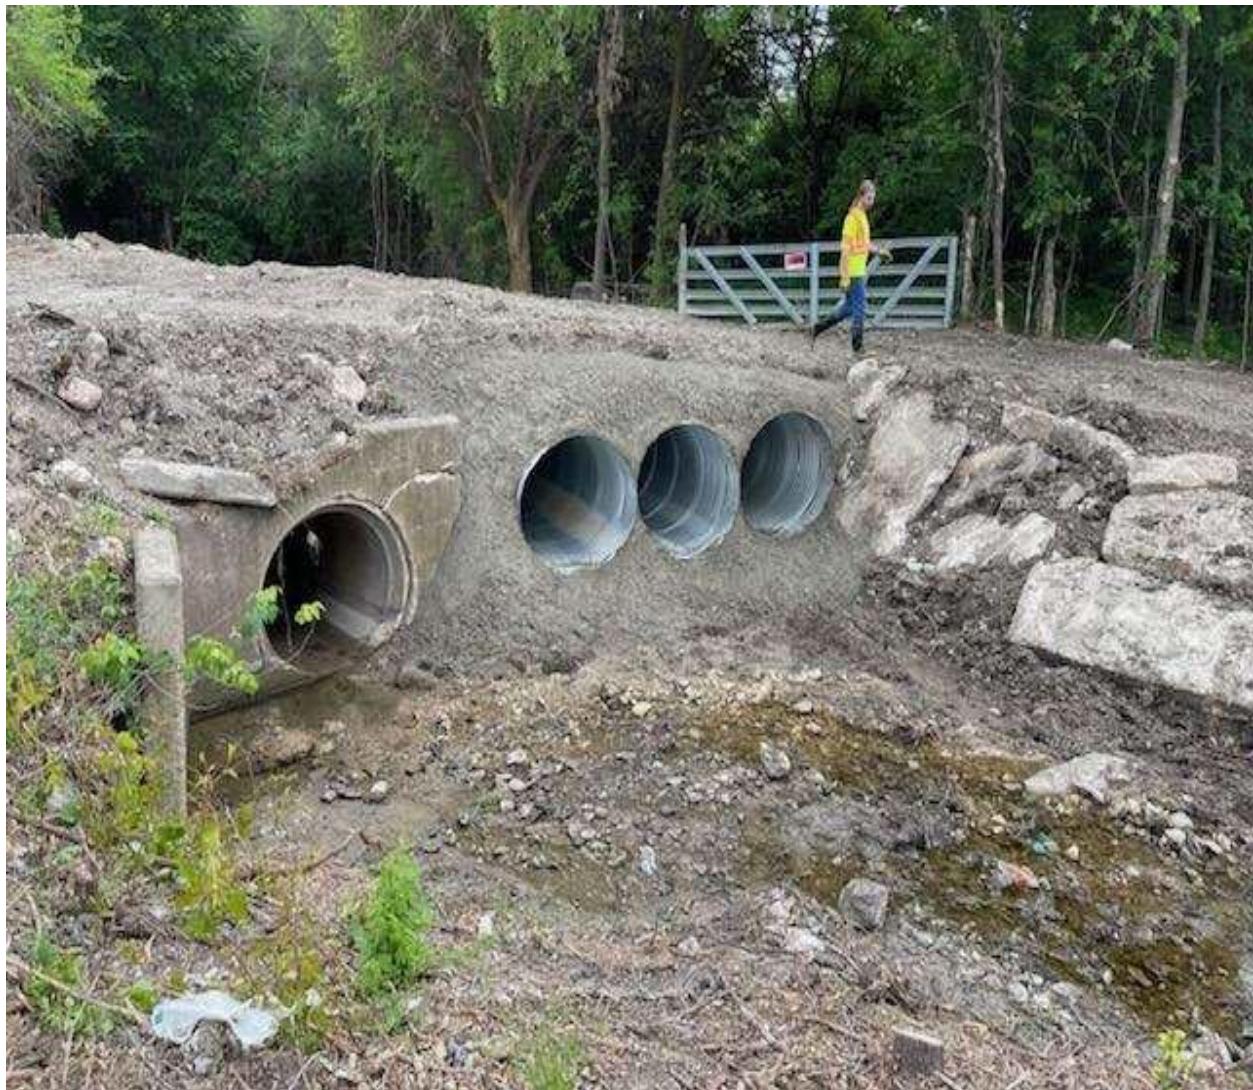
(The original horn is on the left, and the horns new are on the right. The new horns were set approximately 12" higher than the old horn to avoid a water line that is in this location.)
